METAL INDUSTRIES RESEARCH & DEVELOPMENT CENTRE
REGIONAL R&D SERVICE DEPARTMENT (TAICHUNG)

TESTING REPORT

- (1).Name of Article : Bolt Seal Type : DH-S (As photo 1)
(2).Seal Classification: High Security Seal
(3).Test Item : Tensile Test
(4).Testing Instrument : Universal Testing Machine
(No.TG0101)
(5).Ambient Temp. : 23°C ; 60% R.H.
(6).Inspection Reference :
According to ISO/PAS 17712 : 2006
(7). Result :

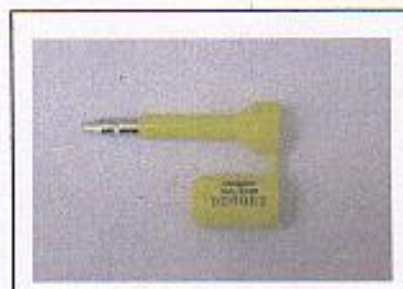
Photo 1

The seal was gripped in a tensile machine and a pull force applied.

Requirement	Load to Failure	10.0 kN
Actual		15.5 kN

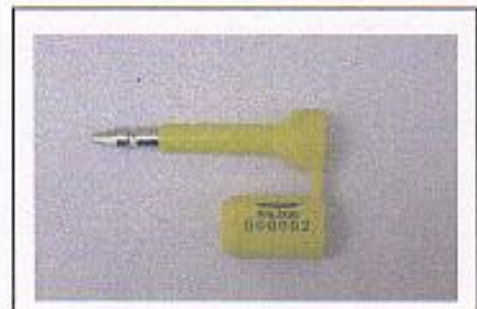
Photo 1

The seal was fixed in a universal testing machine to withstand cutting with shearing blades and a compressive load applied slowly until the seal is severed.

Requirements	Load to Failure	341 kgf
Actual		2060 kgf

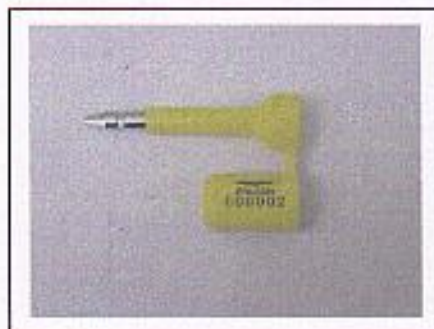
Photo 1

Fix the locking end on the universal testing machine in a horizontal position.
Apply a load on the remaining portion of the seal at a distance (the moment arm) above the fixed end so as to bend the seal 90 degrees.

Requirements	Bending Moment to Failure	50 Nm
Actual		78 Nm

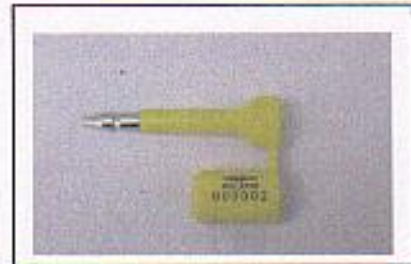
Photo 1

The impact test is performed at 18 degrees C and minus 27 degrees C of temperature.
The impact load is applied at the locking mechanism of the seal in the direction
opposite the direction used in locking the seal.
The initial impact load is applied 5 times at a load equivalent to 13.56 J.
Subsequent impact test is applied 5 times at a load equivalent to 27.12 J.
The final impact load is applied 5 times at a load equivalent to 40.68 J.

Impact Test	5 times at a load		
	13.56J	27.12J	40.68J
Actual	PASS	PASS	PASS
